# IMPACT RESISTANCE OF COMPOSITE FAN BLADES

GENERAL ELECTRIC COMPANY  
AIRCRAFT ENGINE GROUP  
Cincinnati, Ohio 45215

NATIONAL AERONAUTICS AND SPACE ADMINISTRATION  
NASA-LEWIS RESEARCH CENTER

Contract NAS3-16777

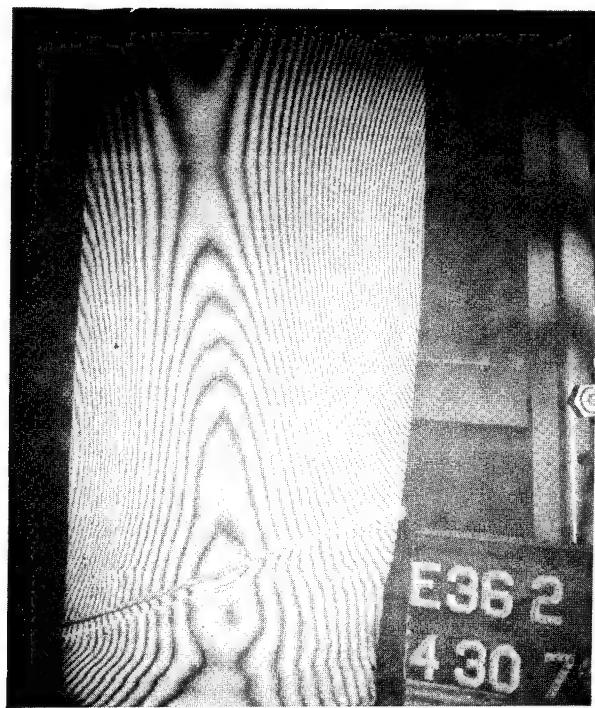
**Figure 11. Holographic NDT of Graphite/Epoxy Blade. Upper and Lower Portions of Each Side are Inspected Separately. Leading Edge Disbonds are Prevalent. Note Trailing Edge Discrepancy.**

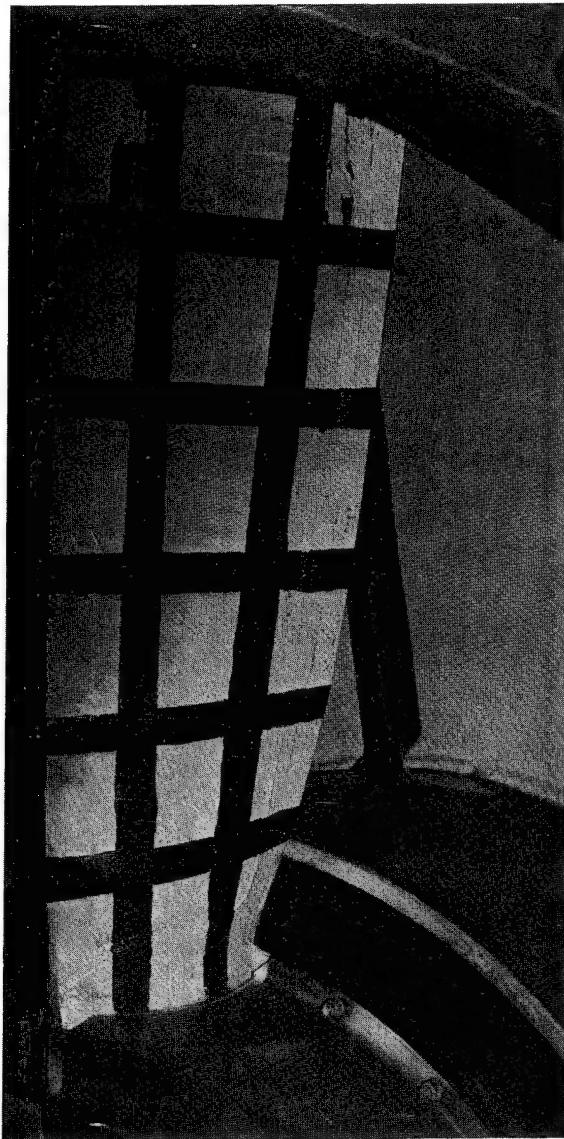
**Figure 23.** TTUCS of Boron/Epoxy Blade S/N NBL.

S/N NB1 - (gravel, iceballs) - Crack along LE protection. Delamination area at base of the blade after impact (Figure 23). Dye penetrant inspection of the dovetail revealed a crack along the LE (Figure 24). Reduced velocity values at base of blade also indicate delamination.

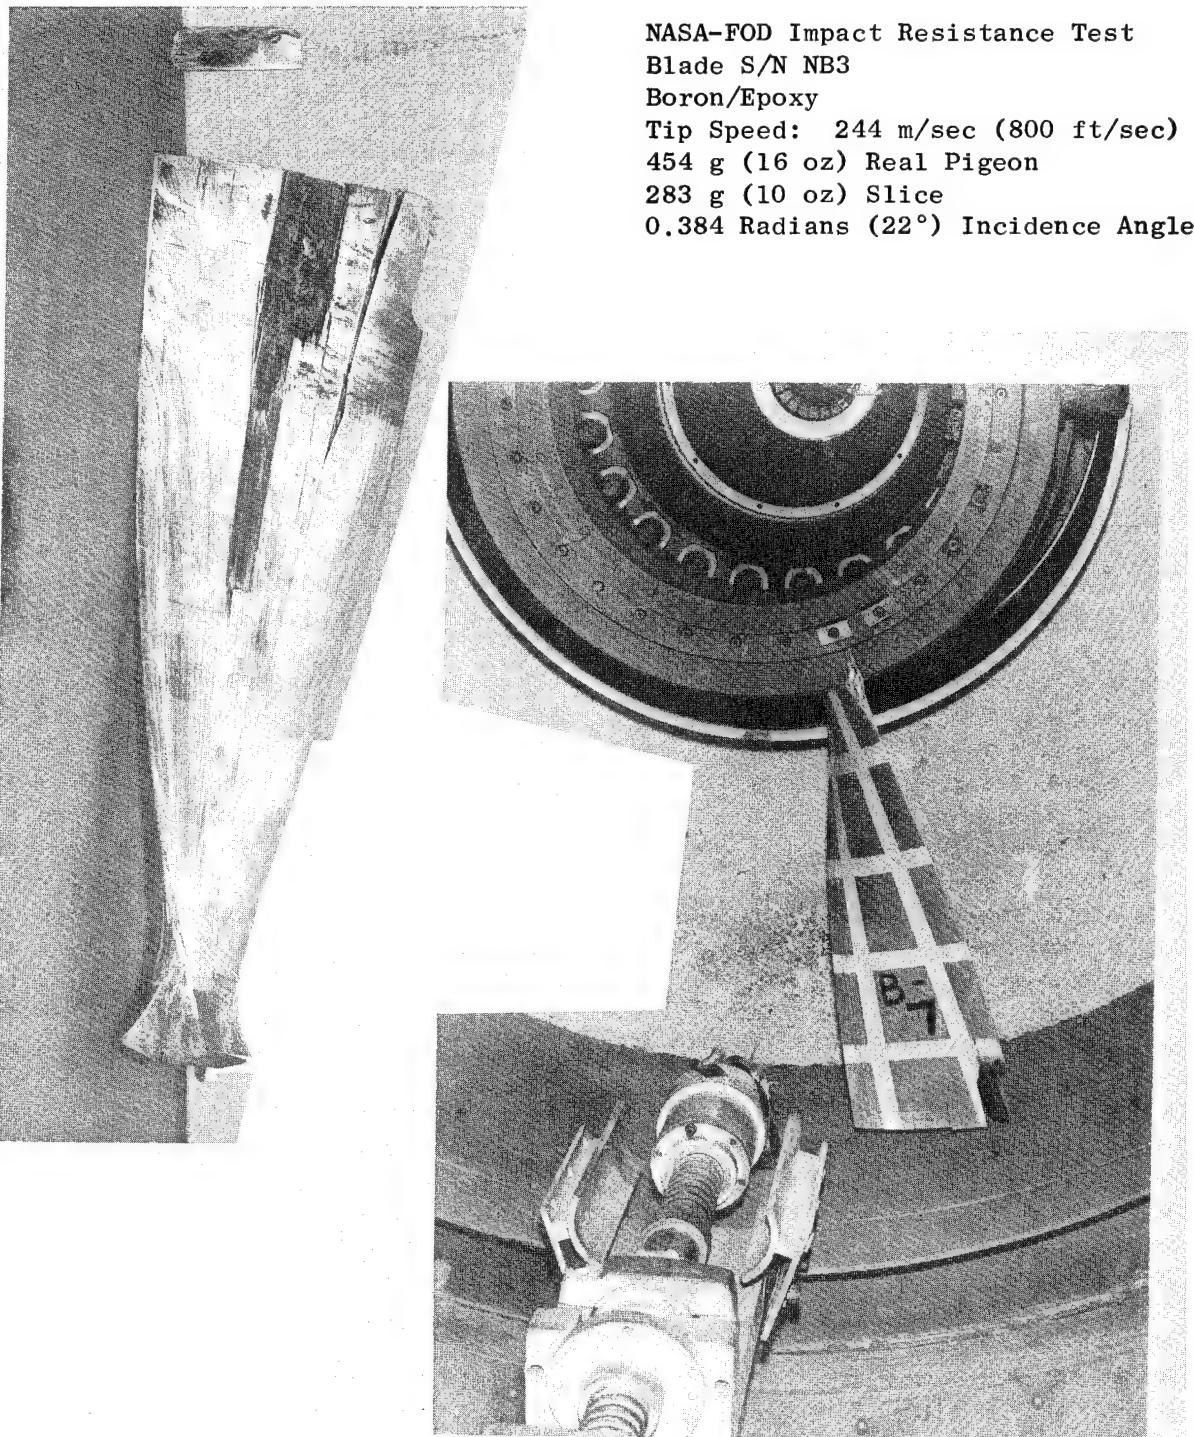
Figure 26. Blade S/N NB3 after Impact.

S/N NB3 - [454 g (16 oz) Pigeon, Figure 26] - Delamination at base of LE. TTUCS after impact indicates blade has internal damage throughout (Figure 27). The dovetail had cracks in both LE and TE as shown by dye penetrant checks (Figure 28). Reduced velocity measurements made over the entire blade surface after impact confirmed the TTUCS data.

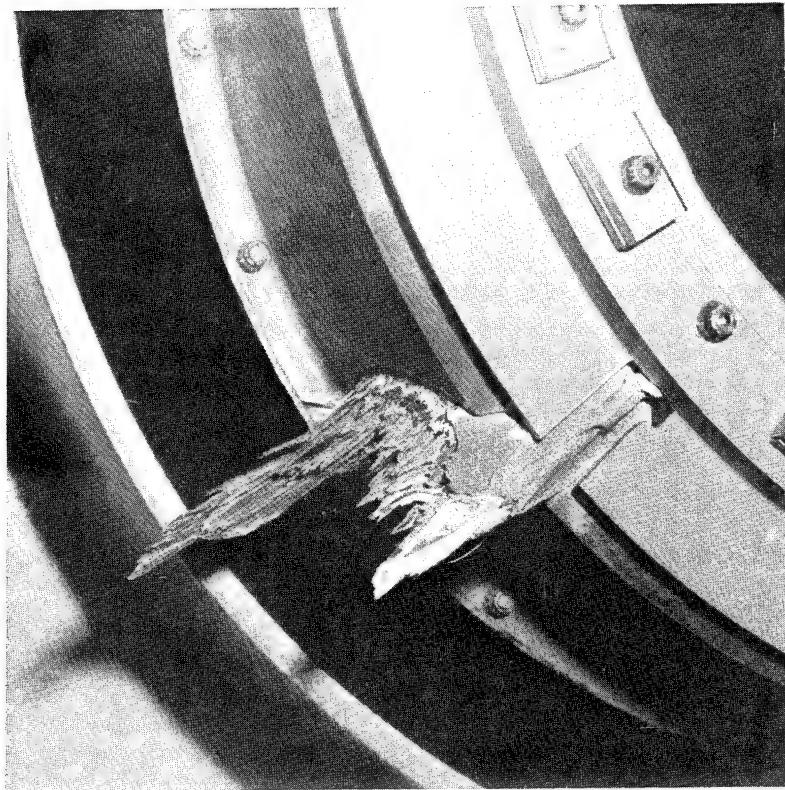
Figure 29. Blade S/N NB4 after Impact

S/N NB4 - [794 g (28 oz) RTV bird, Figure 29] - No NDE performed after impact. Blade broke off at root.

NASA-FOD Impact Resistance Test  
Blade S/N NB4  
Boron/Epoxy  
Tip Speed: 244 m/sec (800 ft/sec)  
794 g (28 oz) RTV Bird  
340 g (12 oz) Slice  
0.384 Radians (22°) Incidence Angle

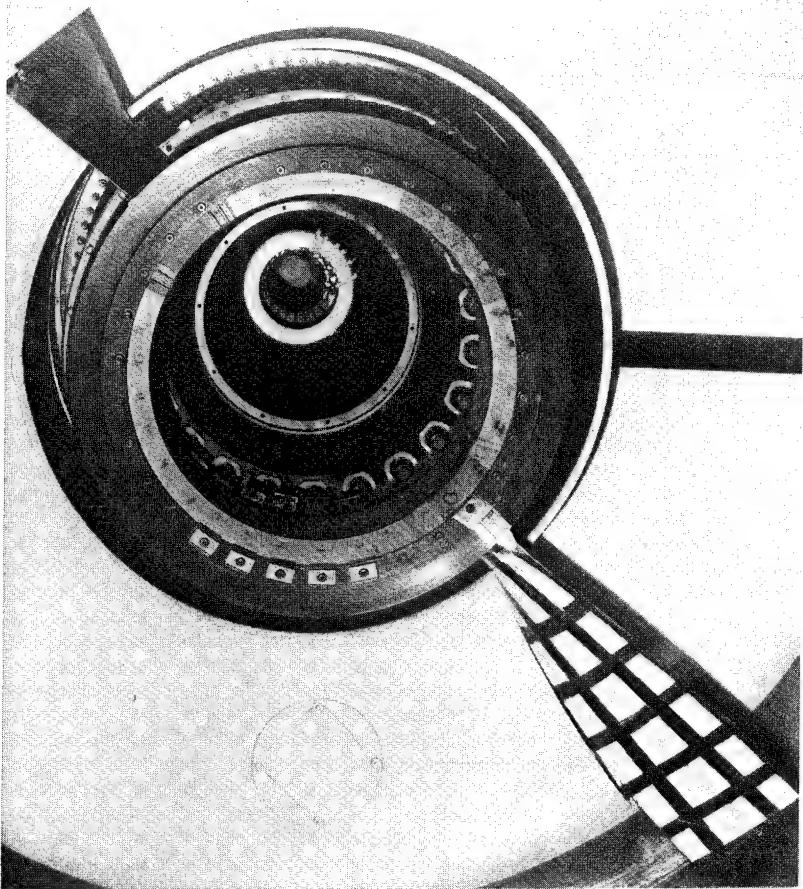
Figure 30. Blade S/N NG1 after Impact.

S/N NG1 - [340 g (12 oz) RTV bird, Figure 30] - Crack in dovetail, slight separation of nickel from LE. TTUCS revealed delamination area at base plus damage at TE tip (Figure 31). Delamination in dovetail can be seen in photographs of dye penetrant check (Figure 32). Low velocity measurements were recorded at base of blade, TE side, indicating internal damage.

NASA-FOD Impact Resistance Test  
Blade S/N NG1  
Graphite/Epoxy  
Tip Speed: 244 m/sec (800 ft/sec)  
340 g (12 oz) RTV Bird  
170 g (6 oz) Slice  
0.384 Radians (22°) Incidence Angle

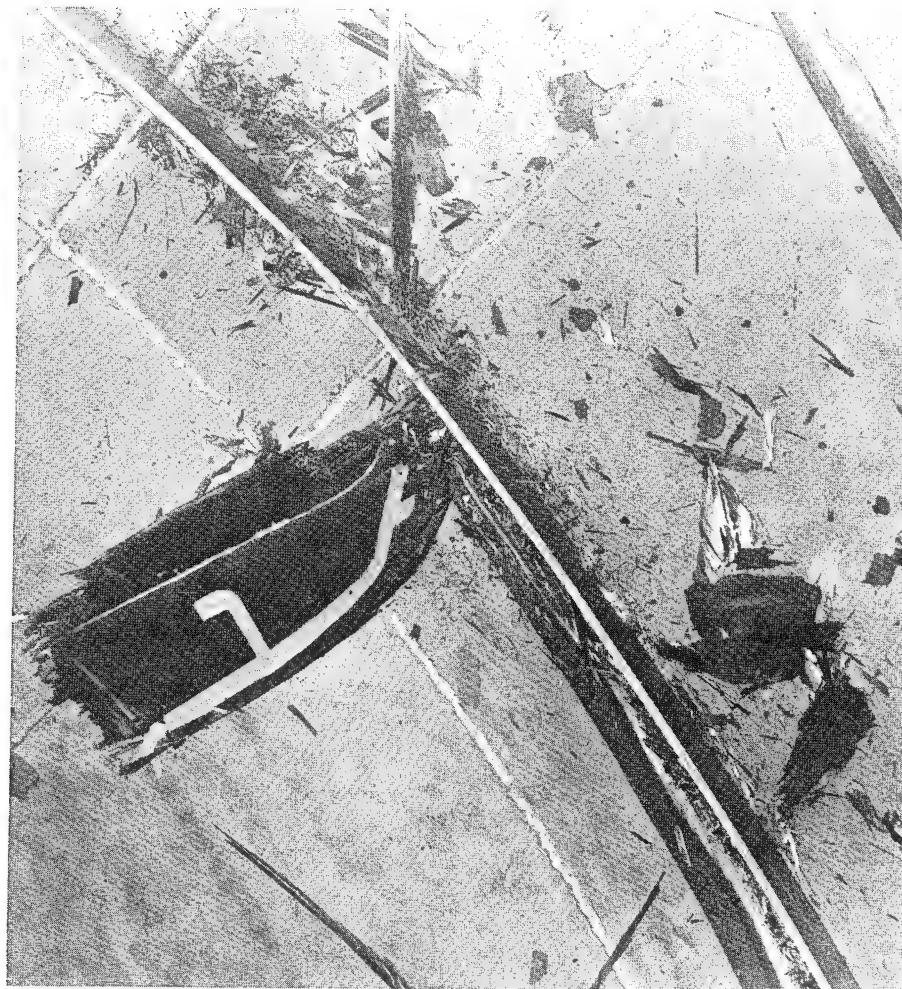
Figure 33. Blade S/N NG2 After Impact.

Following Impact with  
3 Each 5.08 cm Diameter  
Tempered Hailstones.  
Total Weight, 210 g (7.4 oz).

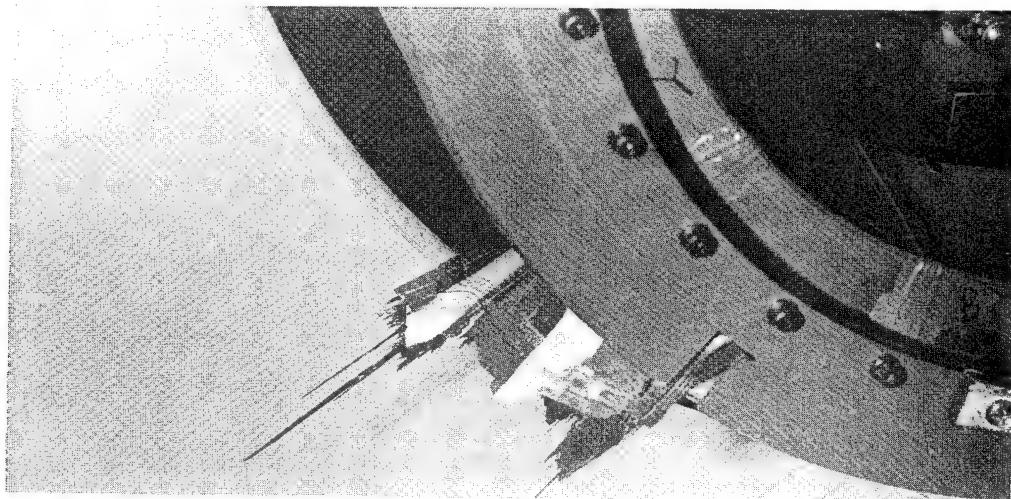
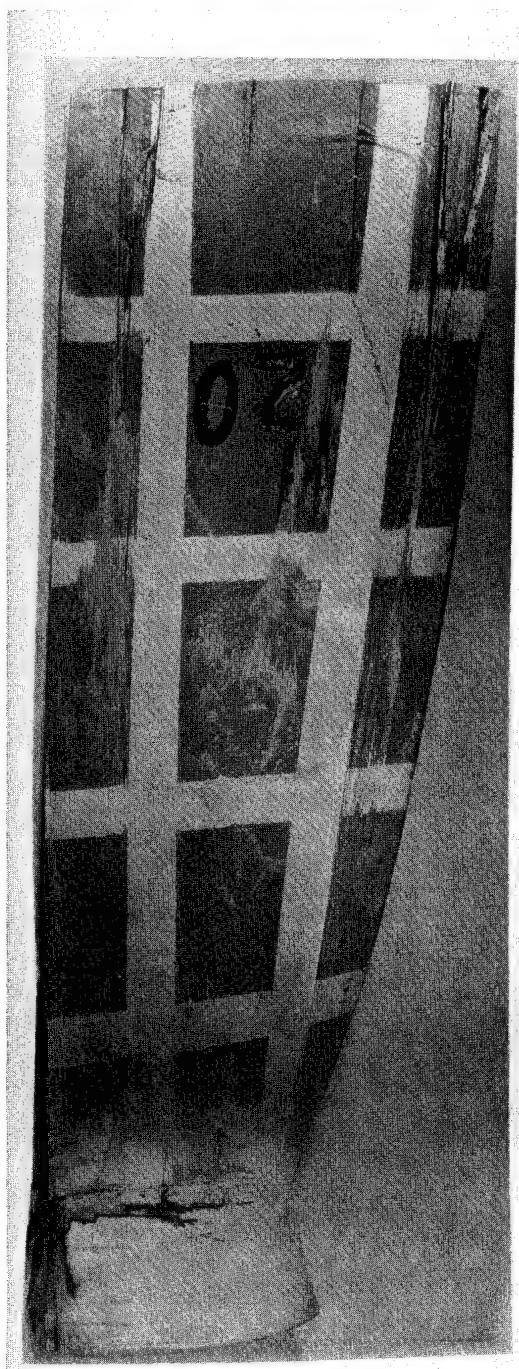
Figure 34. Blade S/N NG3 after Impact.

S/N NG3 - [794 g (28 oz) RTV bird, Figure 34] - No NDE after test - too severely damaged.

NASA-FOD Impact Resistance Test  
Blade S/N NG3  
Graphite/Epoxy  
Tip Speed: 244 m/sec (800 ft/sec)  
794 g (28 oz) RTV Bird  
340 g (12 oz) Slice  
0.384 Radians (22°) Incidence Angle

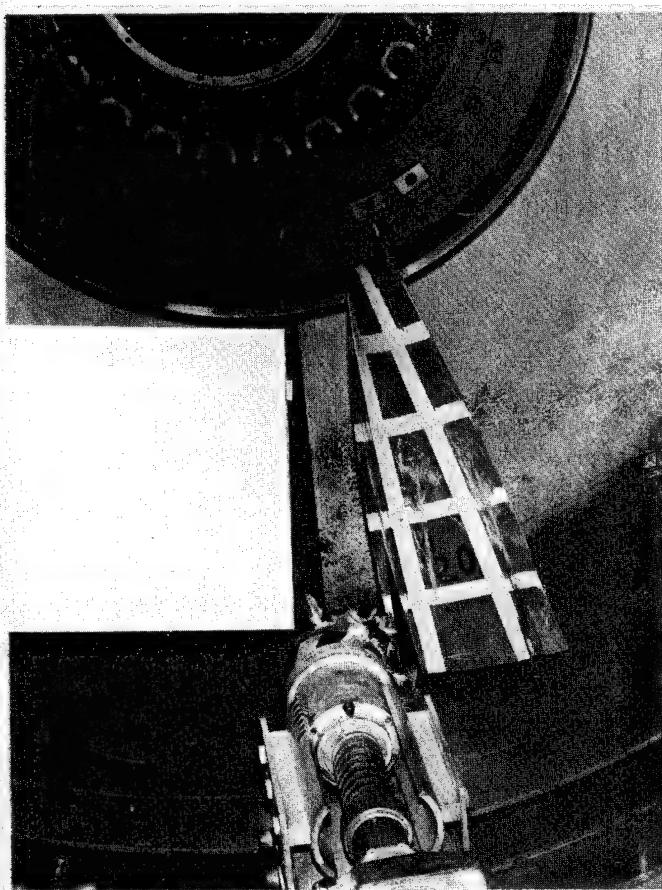
Figure 35. Blade S/N NG4 after Impact.

NASA-FOD Impact Resistance Test  
Blade S/N NG4  
Graphite/Epoxy  
Tip Speed: 244 m/sec (800 ft/sec)  
454 g (16 oz) Real Pigeon  
312 g (11 oz) Slice  
0.384 Radians (22°) Incidence Angle

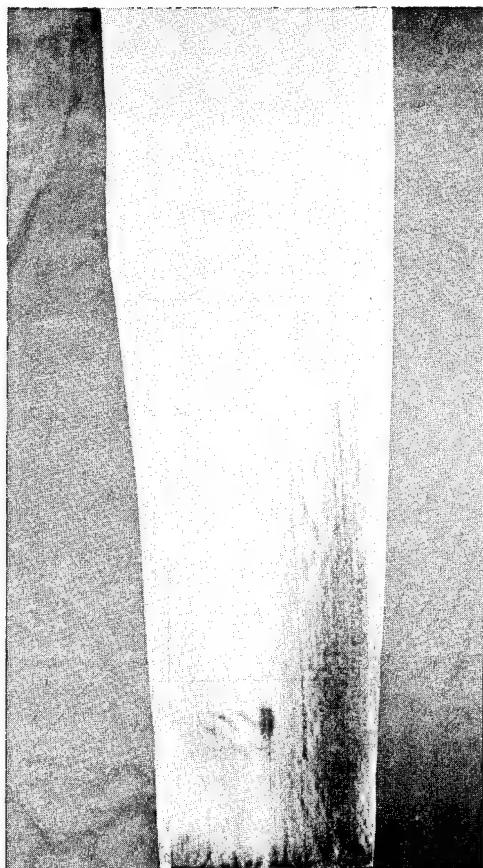
Figure 36. TTUCS of Graphite/Epoxy Blade S/N NG4.

S/N NG4 - [454 g (16 oz) pigeon, Figure 35] - Severe root damage. TTUCS shows large delamination area running from dovetail to midway up the blade (Figure 36). Tip badly delaminated also. Dye penetrant inspection showed crack running around entire dovetail (Figure 37).

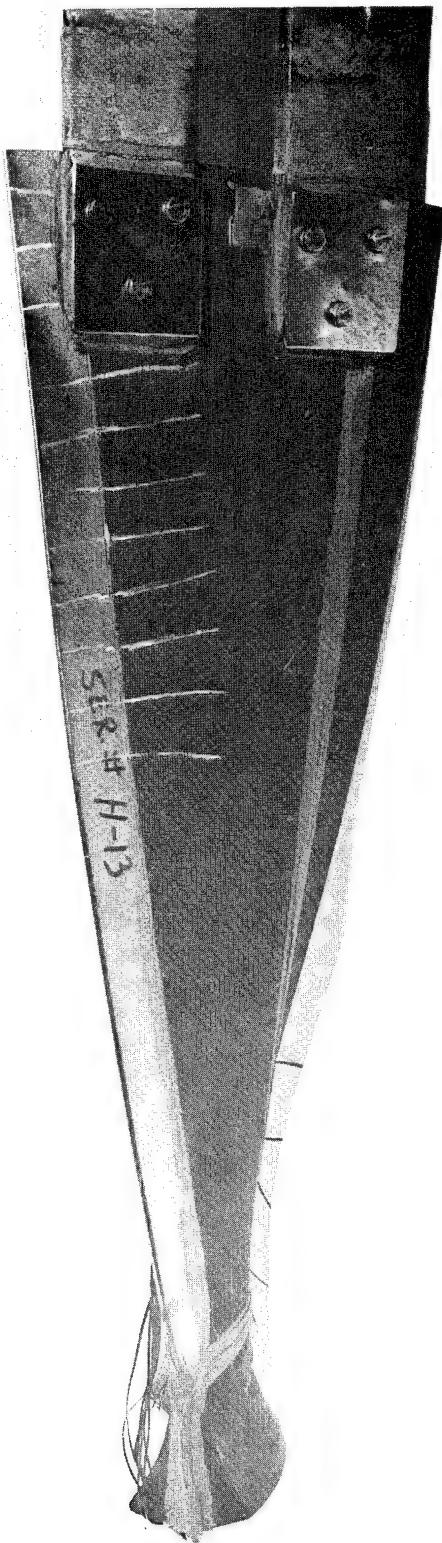
**Figure 38.** NG5 Graphite/Epoxy Blade  
after Impact (Convex Surface),  
Test No. STOL 1.

The most striking feature of these tests is the generally good appearance of the composite blades after impact. The graphite/epoxy blade (NG5) is shown in Figures 38 (convex view) and 39 (concave view). The only visible damage to the blade was a rather clean crack extending down from the tip section a distance of less than 7.62 cm (3 in.). The chalk coating can still be seen adjacent to the projectile part (Figure 39) which extended across the entire blade chord. The convex surface of the blade was marked only with short line segments extending back from the leading edge. The lines can be seen clearly to the leading edge, demonstrating, thereby, that no projectile interaction has taken place on the convex surface. The axial load measured after the test showed the same level as set up before the test.

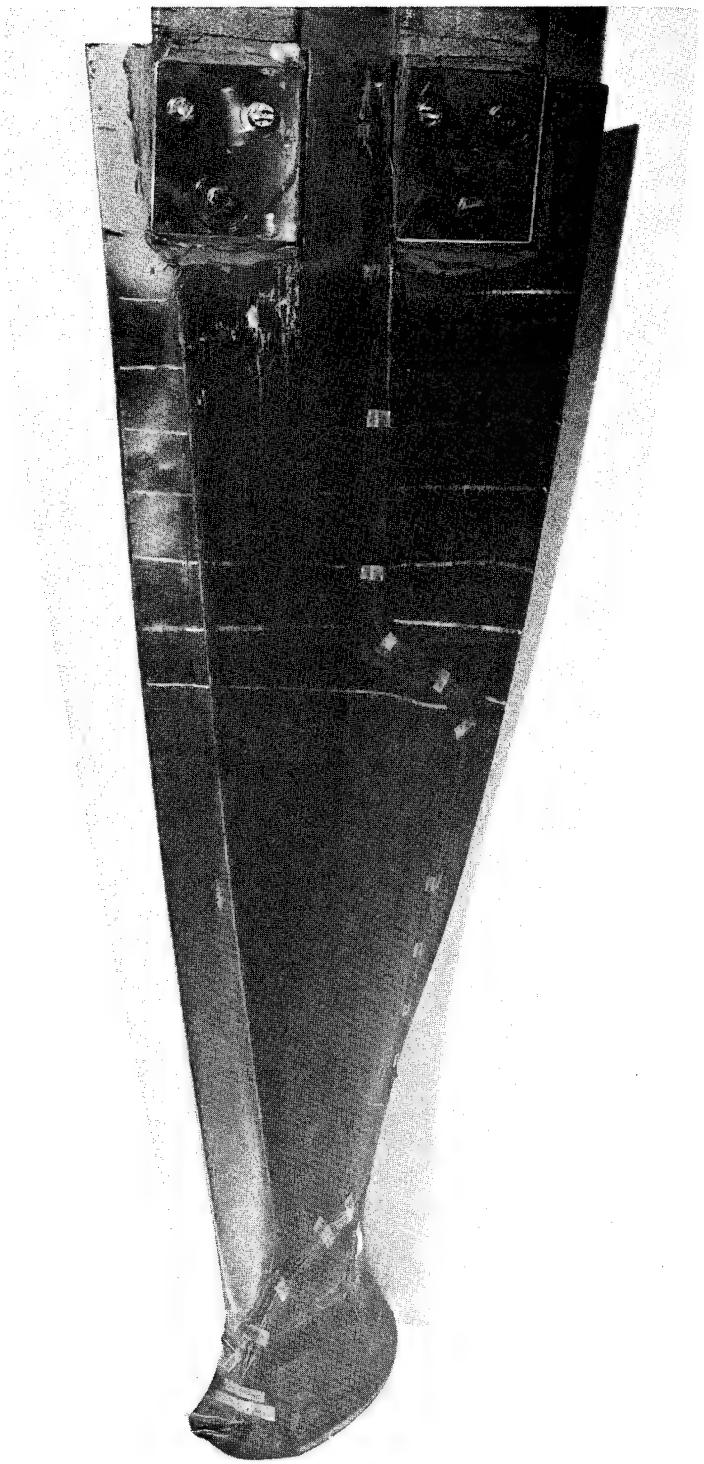
**Figure 40.** NB5 Boron/Epoxy Blade after Impact (Convex Surface), Test No. STOL 2.

The boron/epoxy blade is shown after impact in Figures 40 (convex) and 41 (concave). This blade was damaged much more severely than the previous one, although it too tolerated the impact well. The principal damage consisted of cracks and multiple delaminations extending down from the tip section and situated again between the loading straps. The damage is especially clear in Figure 41. Similar indications of projectile interaction can be seen here as well.

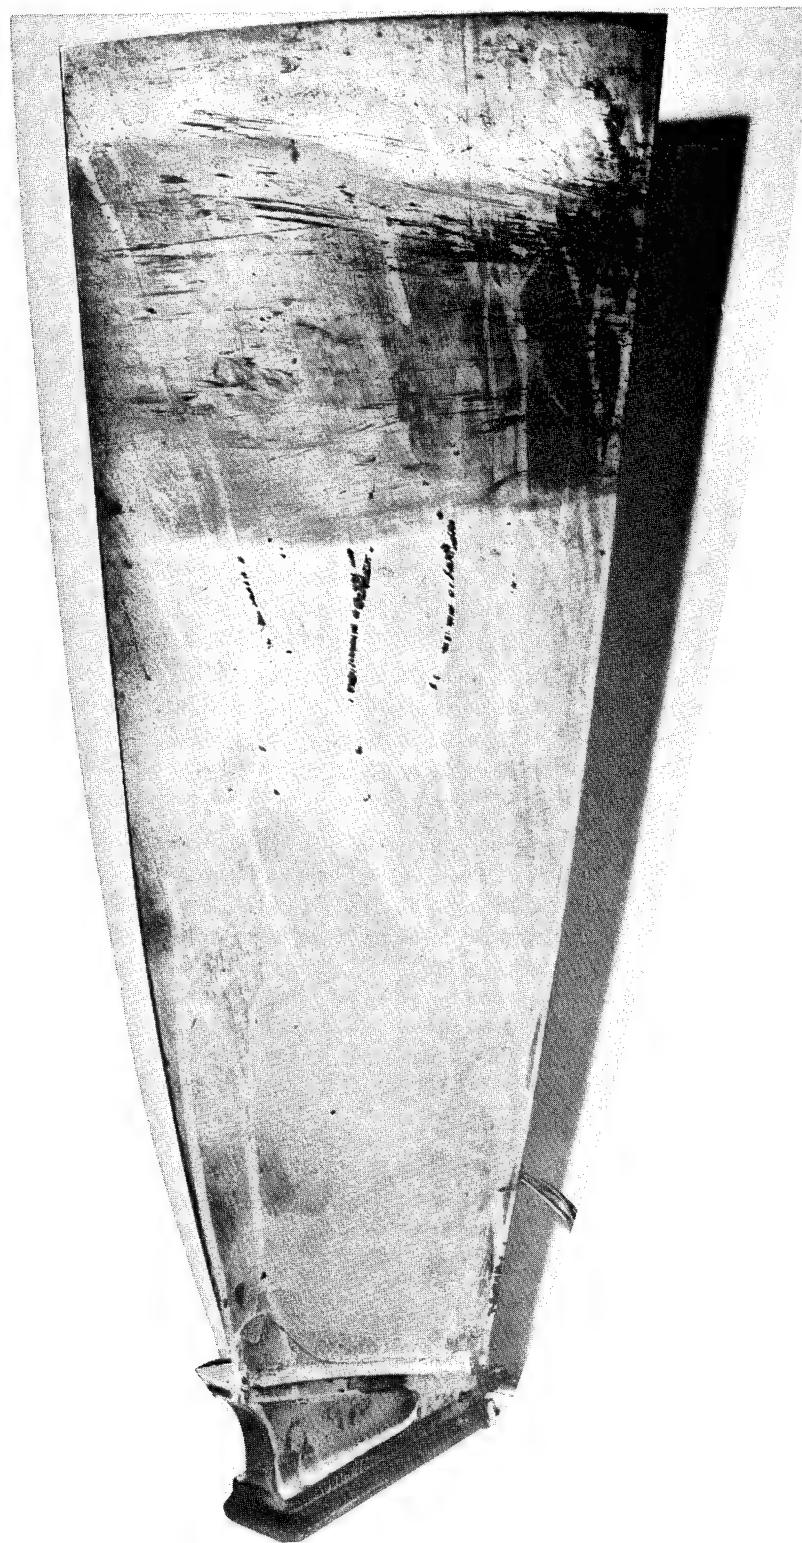
Figure 43. Titanium Blade after Impact  
(Concave Surface), Test No.  
STOL 3.

The titanium blade impacted in the third test is shown in Figures 42 (convex) and 43 (concave). The blade was not fractured but was perceptibly deformed at the leading and trailing edges along the projectile path.

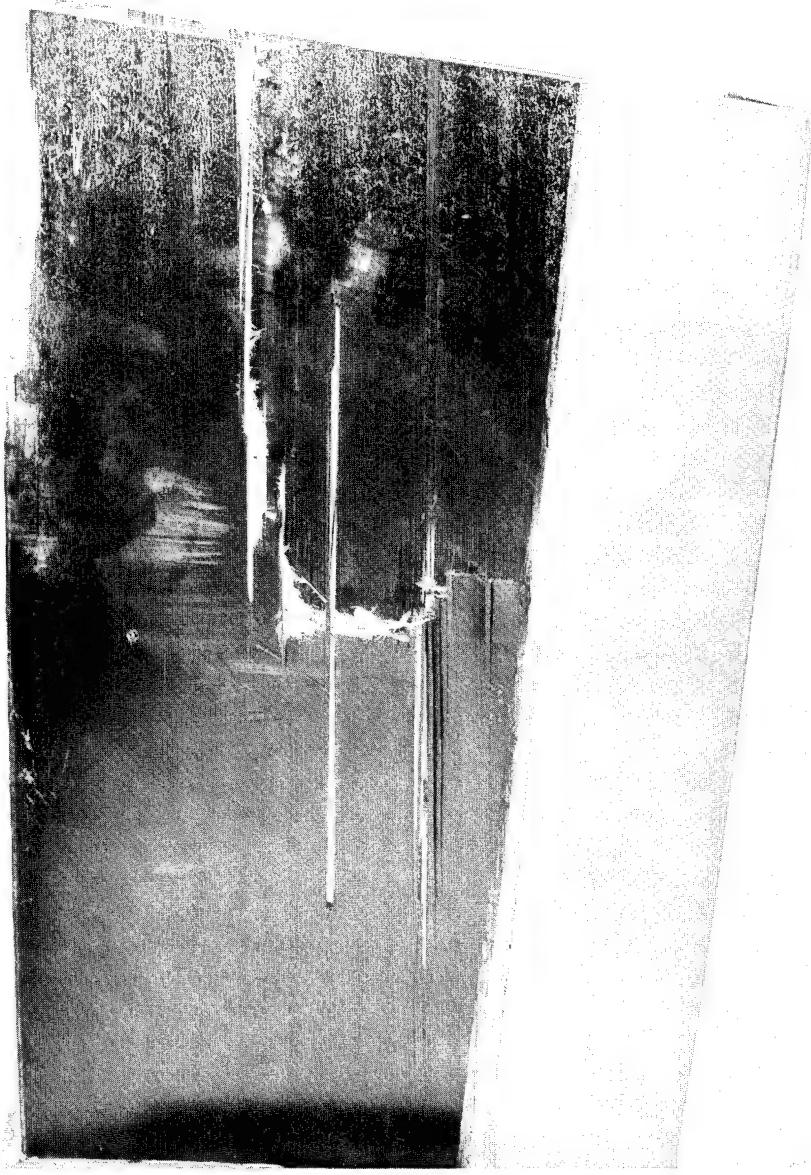
Figure 51. Panel S/N 2 After Impact.

NASA-FOD Program  
Panel S/N 2  
PR 288/80% AU/20% S-Glass  
RTV Simulated Bird  
Bird Size: 227 g (8 oz)  
Half Bite  
Impact Velocity: 215 m/sec (707 ft/sec)  
Incidence Angle: 0.384 Radians (22°)

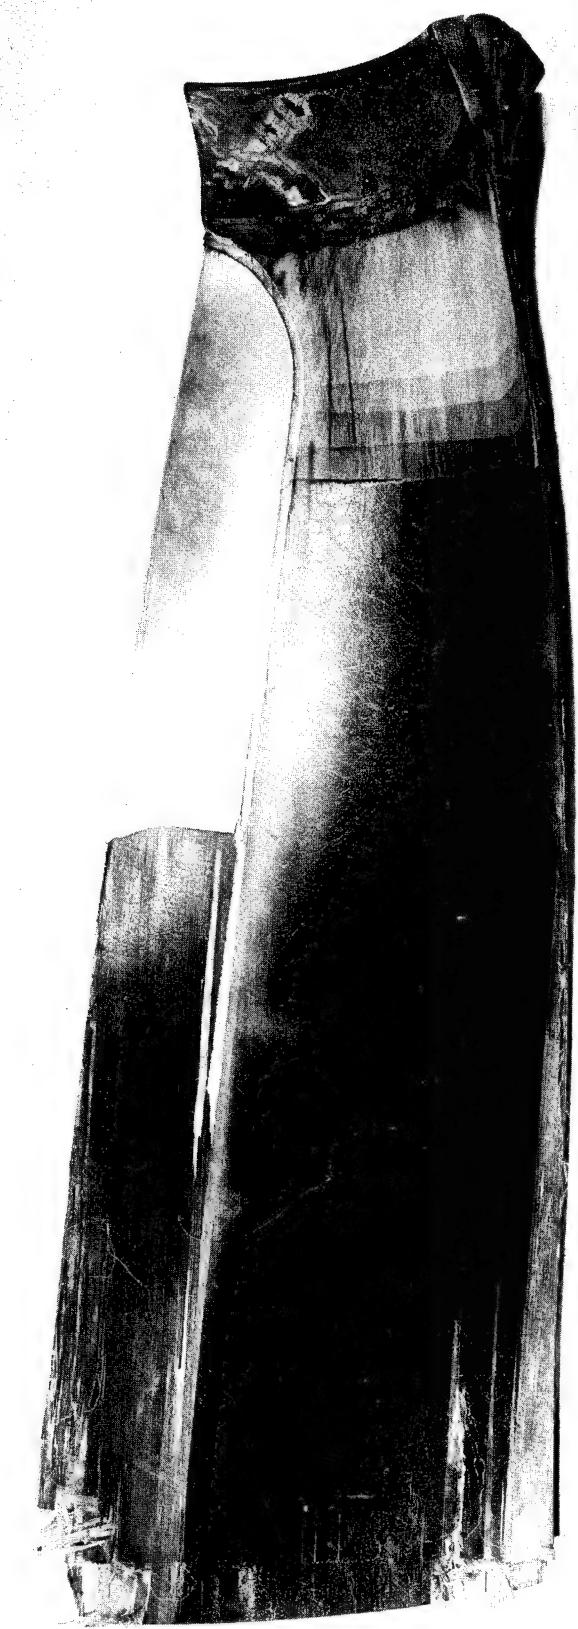
Figure 57. Blade S/N H/E1 After Impact.

NASA-FOD Program  
Blade S/N H/E1  
Design No. 2 Material/Lay-Up  
RTV Simulated Bird  
Bird Size: 794 g (28 oz)  
Slice Size: 200 g (7 oz)  
Blade Tip Speed: 244 m/sec (800 ft/sec)  
Incidence Angle: 0.384 Radians (22°)

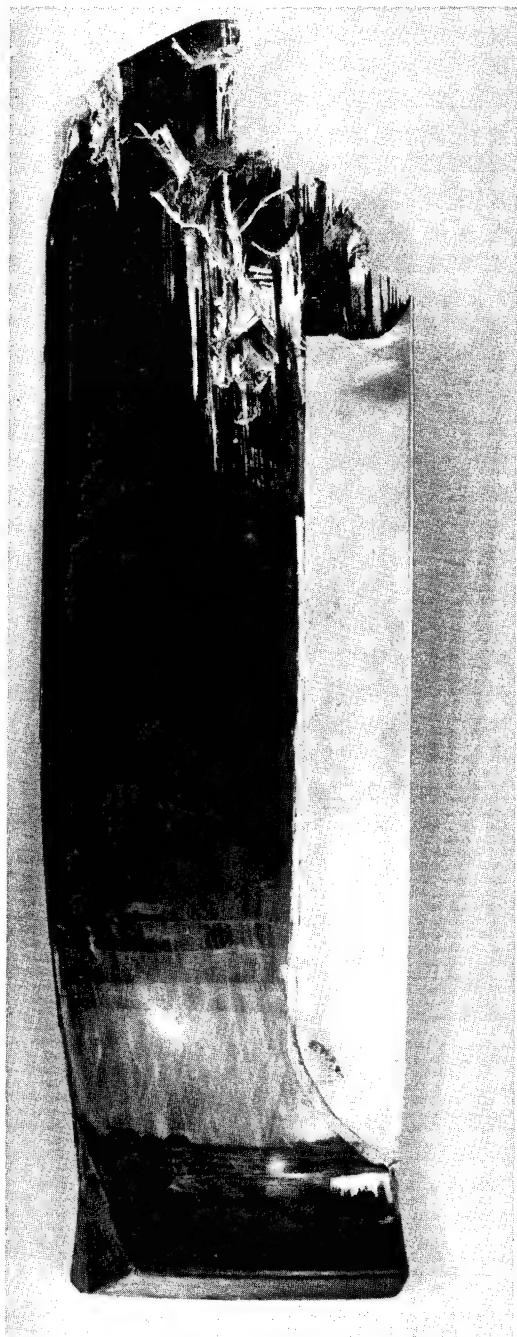
Figure 58. Blade S/N H/E2 After Impact.

NASA-FOD Program  
Blade S/N H/E2  
Design No. 2 Material/Lay-Up  
RTV Simulated Bird  
Bird Size: 1360 g (48 oz)  
Slice Size: 680 g (24 oz)  
Blade Tip Speed: 244 m/sec (800 ft/sec)  
Incidence Angle: 0.384 Radians (22°)

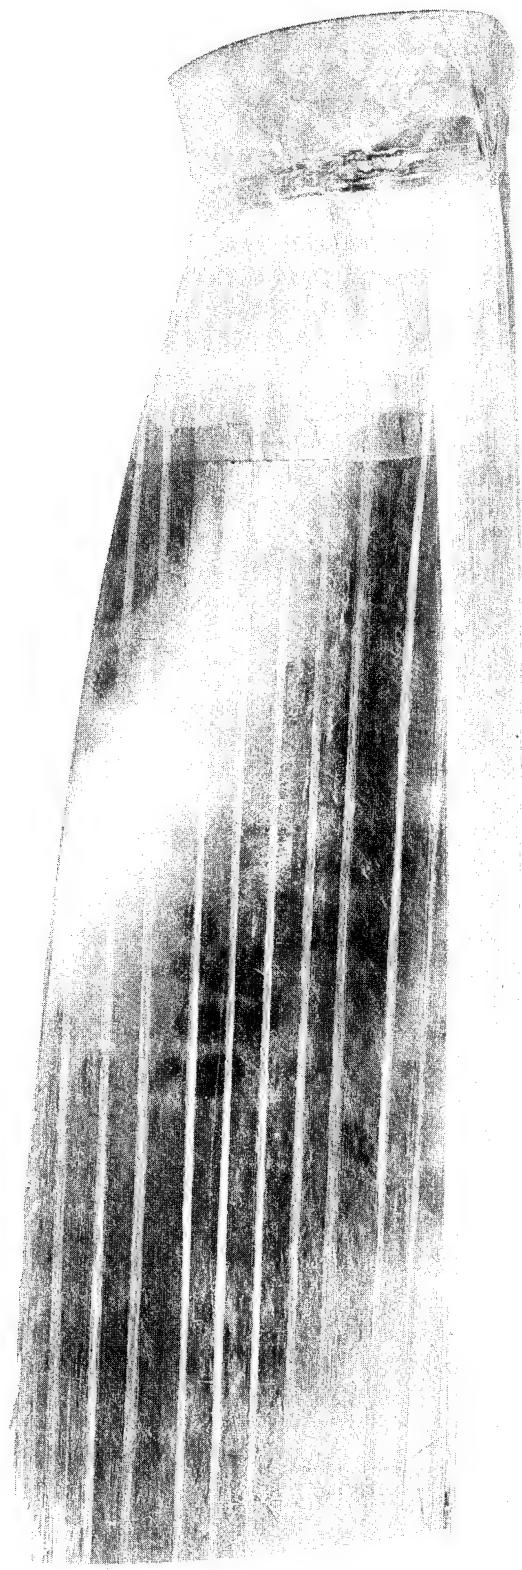
Figure 59. Blade S/N H/E3 After Impact.

NASA-FOD Program  
Blade S/N H/E3  
Design No. 2 Material  
Real Mallard Duck  
Bird Size: 1134 g (40 oz)  
Slice Size: 680 g (24 oz)  
Blade Tip Speed: 244 m/sec (800 ft/sec)  
Incidence Angle: 0.384 Radians (22°)

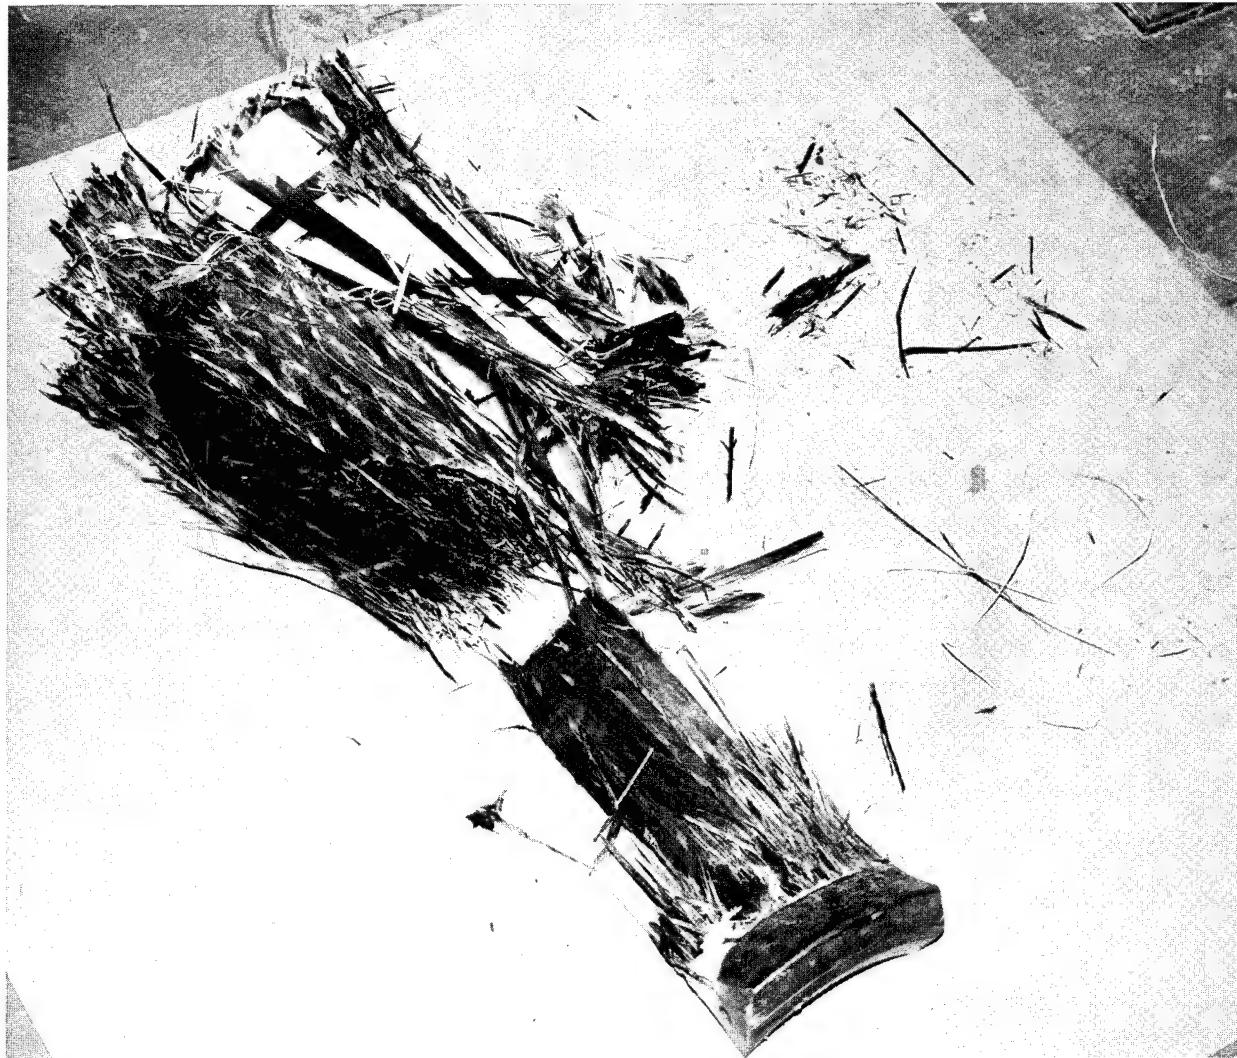
Figure 60. Blade S/N H/E4 After Impact.

NASA-FOD Program  
Blade S/N H/E4  
Design No. 1 Material/Lay-Up  
RTV Simulated Bird  
Bird Size: 794 g (28 oz)  
Slice Size: 227 g (8 oz)  
Blade Tip Speed: 244 m/sec (800 ft/sec)  
Incidence Angle: 0.384 Radians (22°)

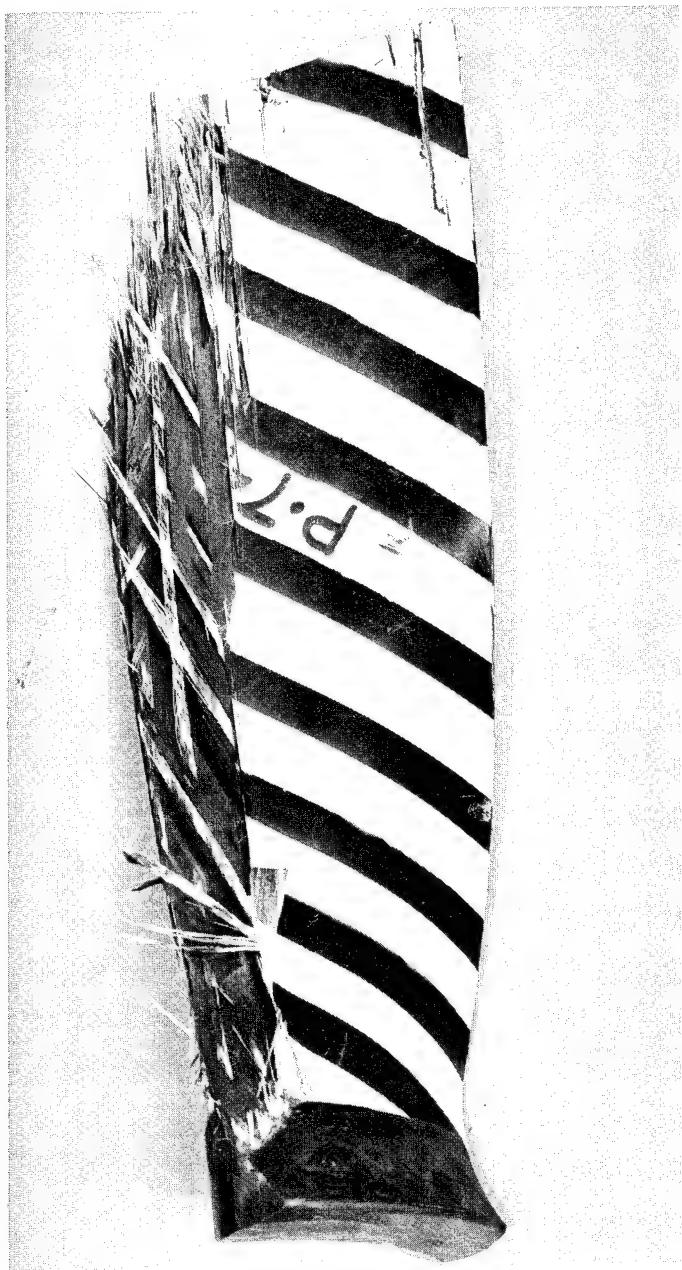
Figure 61. Blade S/N H/E5 After Impact.

NASA-FOD Program  
Blade S/N H/E5  
Design No. 1 Material  
RTV Simulated Bird  
Bird Size: 1360 g (48 oz)  
Slice Size: 765 g (27 oz)  
Blade Tip Speed: 244 m/sec (800 ft/sec)  
Incidence Angle: 0.384 Radians (22°)
